SUBJECT: Summary of Stage I Field Activities and Investigation Results

Moline Street PCB Site - 3555 Moline Street, Aurora, Adams County, Colorado

STAGE I SUMMARY TECHNICAL MEMORANDUM Moline Street PCB Site

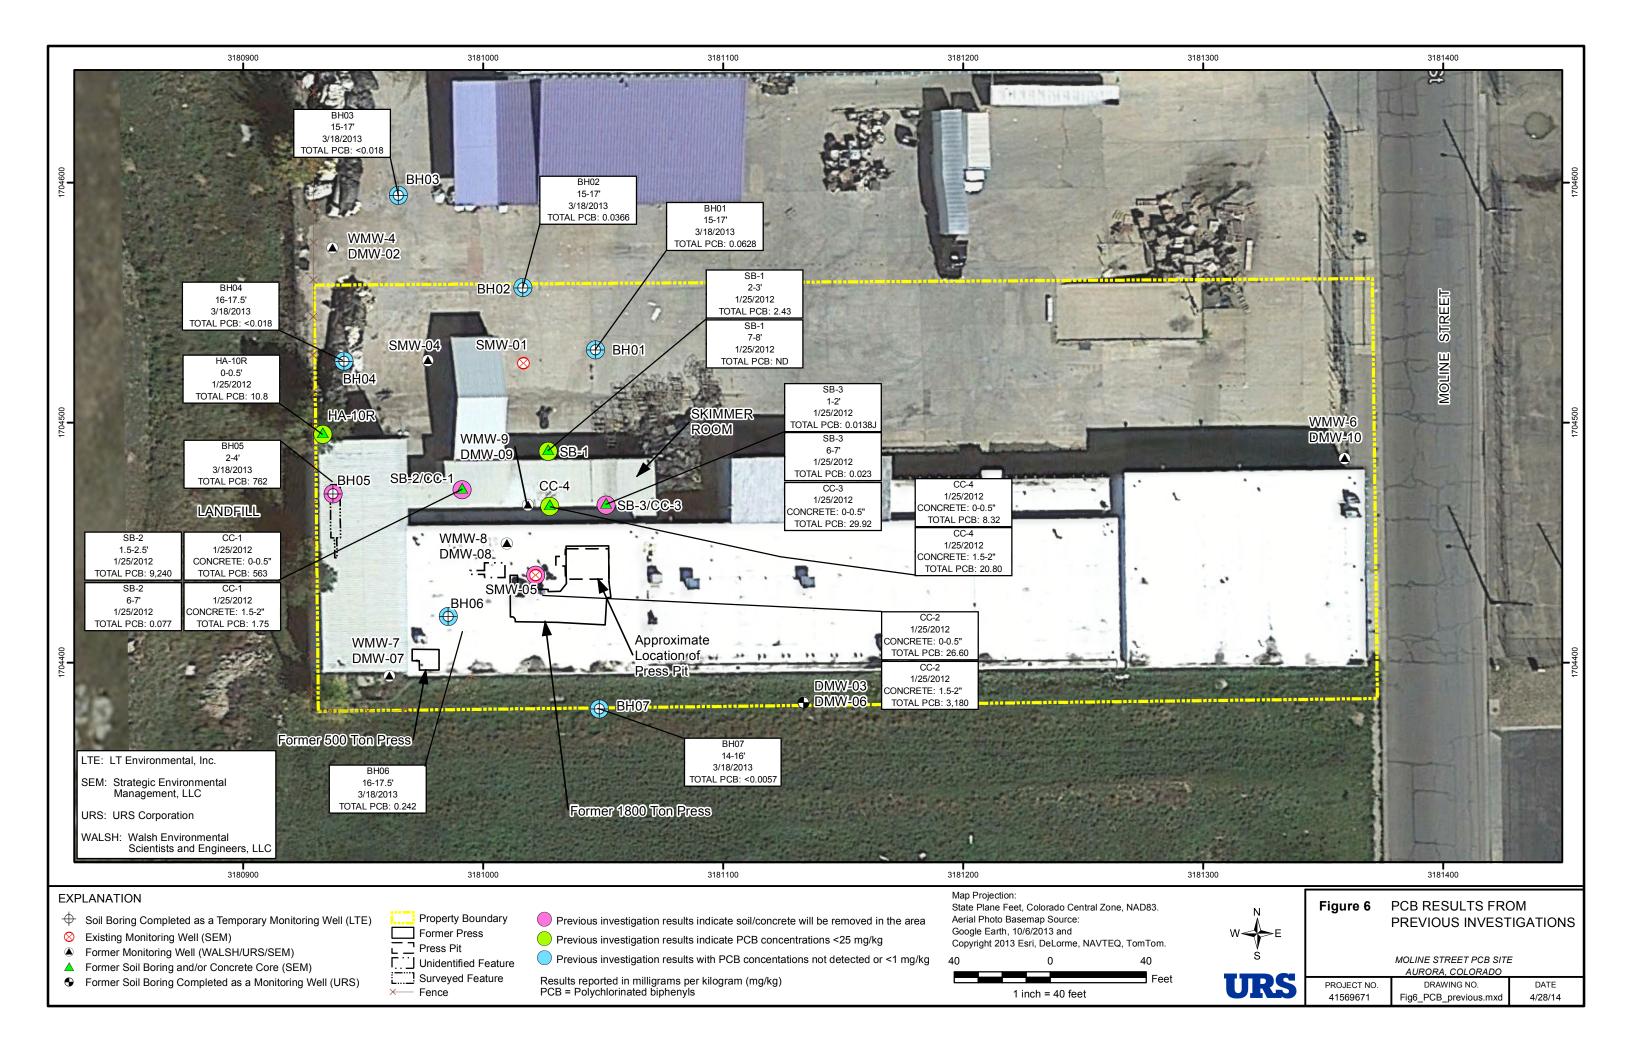
Stage I results were used in conjunction with historical results (presented on Figure 6) to evaluate soil and concrete contamination. Figure 7 presents results for locations that had one or more PCB action level exceedance and indicates the estimated depth interval of contamination. URS used this information to delineate the horizontal and vertical extent of soil and concrete contamination, as shown in Figure 8. Areas for concrete sawcutting were identified based on concrete results, the approximate soil removal extent, and ease of earthworking activities, as shown on Figure 8. In areas where analytical or field test kit results were not obtained, the removal area was delineated based on a conceptual understanding of potential releases or sources of contamination.

For example, upon review of historical documents in conjunction with field observations and Stage I results, URS believes that hydraulic oils containing PCBs leaked around the perimeter of the base of the press pit at the joint between the stem wall and pit slab, to a depth of at least 6 feet bgs. Based on historical inspections of the pit, the concrete slab (with a base of 4 feet bgs) is believed to be saturated with oils, and therefore, likely will need to be removed. Upon further review of the historical documents along with the Stage I results, URS believes that the press pit was located approximately 30 feet farther to the east than estimated in the Revised Work Plan (URS 2014).

- URS and their subcontractor (hereafter referred to collectively as URS) hang plastic sheeting between Buildings D and E, and Buildings E and F
- URS removes Building C
- URS sawcuts concrete in delineated areas
- URS excavates contaminated soils and collects confirmation samples
- Upon achieving soil concentrations below cleanup levels along the sidewalls and base of the excavation, URS surveys excavations
- URS backfills and compacts (with compaction testing) excavation areas
- URS places concrete over excavated areas and surveys final grade
- URS cleans designated portions of building
- URS conducts final wipe sampling of building
